Technical Note

June 1987

Timber Piling Barrier and Chemical Preservation Annual Costs Comparison

NAVAL CIVIL ENGINEERING LABORATORY PORT HUENEME, CALIFORNIA 93043

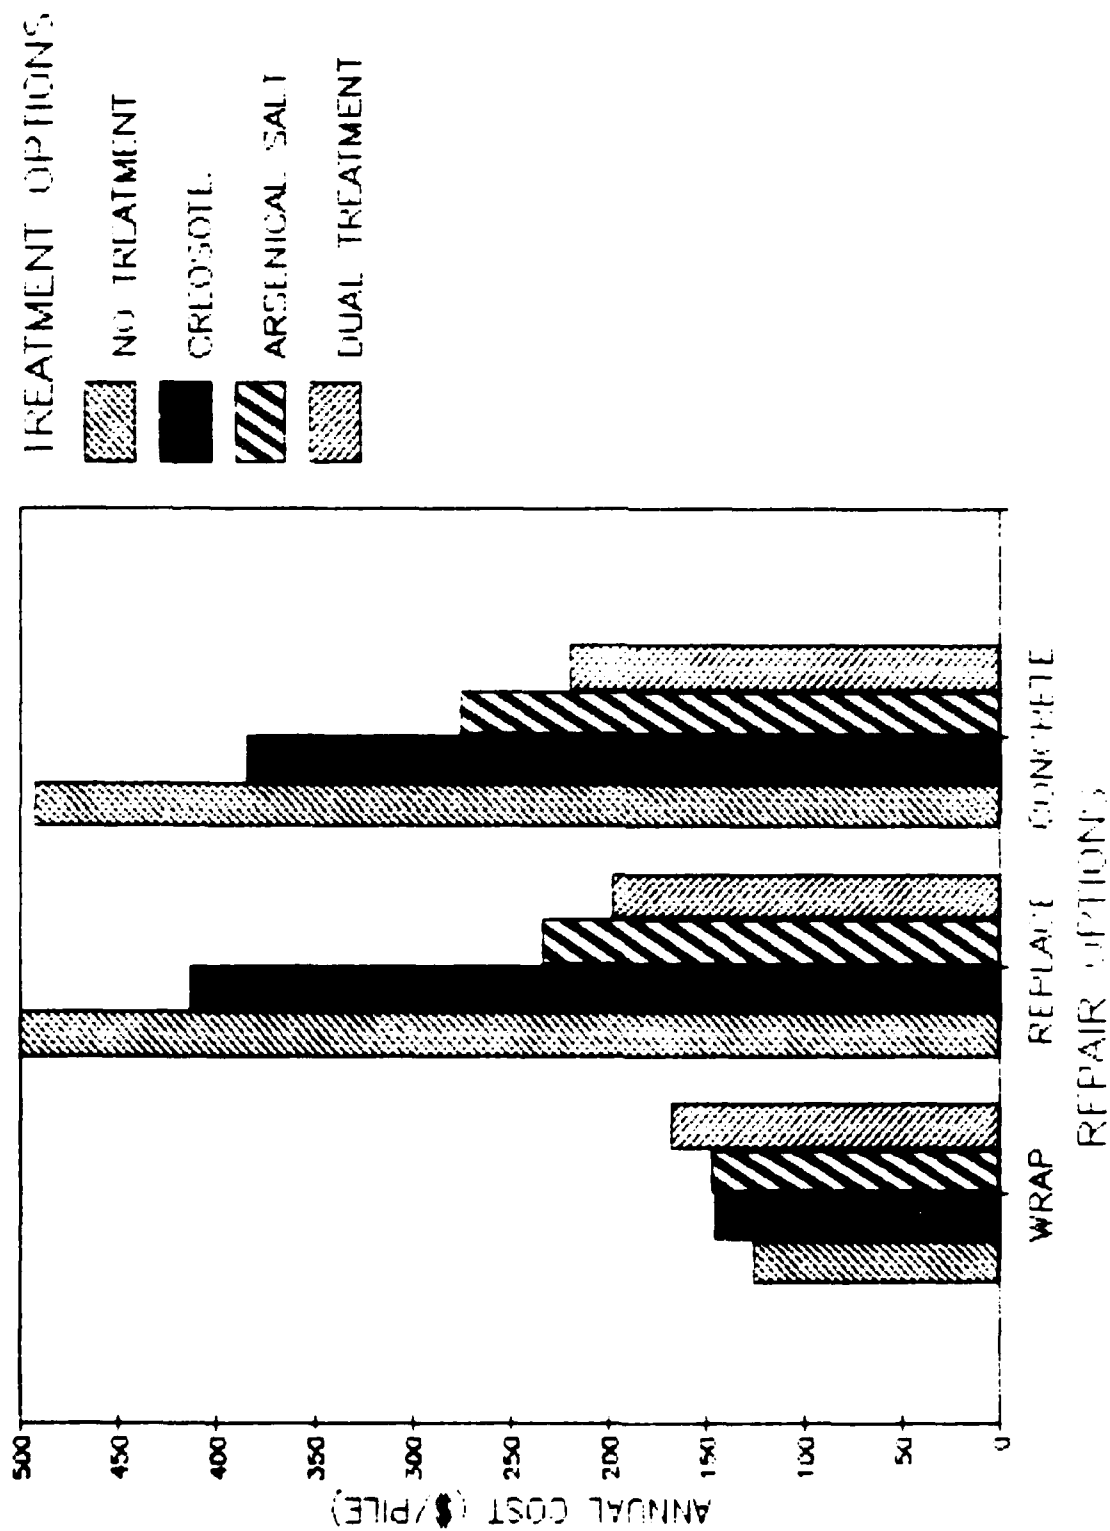
Figure 1. Calculated annual costs of marine timber bearing piling treatment and repair options in tropical areas.

The calculated average annual costs of installing timber bearing piling are presented in Table 3 and Figures 1 through 4. Included are the cost of treatment and repair or protection options for treated and untreated piling installed in tropical, subtropical, temperate, and polar locations. Costs for these piling depend on the treatment, the method of repair or protection and the amount of time before the repair is required, i.e., the durability of the original treatment. Protection by wrapping with PVC is generally required about 2 years before either pile replacement or repair by encasement with concrete and is, therefore, compared on that basis in these tables. The installation of untreated piling protected by PVC wrapping is included in these tables but is not recommended because long-term testing has not yet demonstrated its efficacy. The calculated annual costs of installing bearing piles wrapped with PVC or PE or coated with PU before driving are:

The calculated costs presented in Figures 1 through 4 show that the least expensive, proven approach to timber bearing piling installation in all geographical areas is to use PVC wrapping after installing the treated piling. The cost differences between piling protection with PVC and repair by concrete encasement or replacement are greater in tropical and subtropical areas because the protection or repairs must be accomplished sooner where biodeterioration rates are higher. The greater durability of treated timber in cooler waters reduces the calculated annual costs because of the deferment of maintenance costs. In tropical and subtropical areas, installing creosoted or arsenical treated bearing piles, to be subsequently protected by PVC wrapping, results in comparable annual costs. In contrast, dual treatment is more expensive. In temperate and polar areas, the least expensive approach is to install creosoted piling protected by PVC wrap.

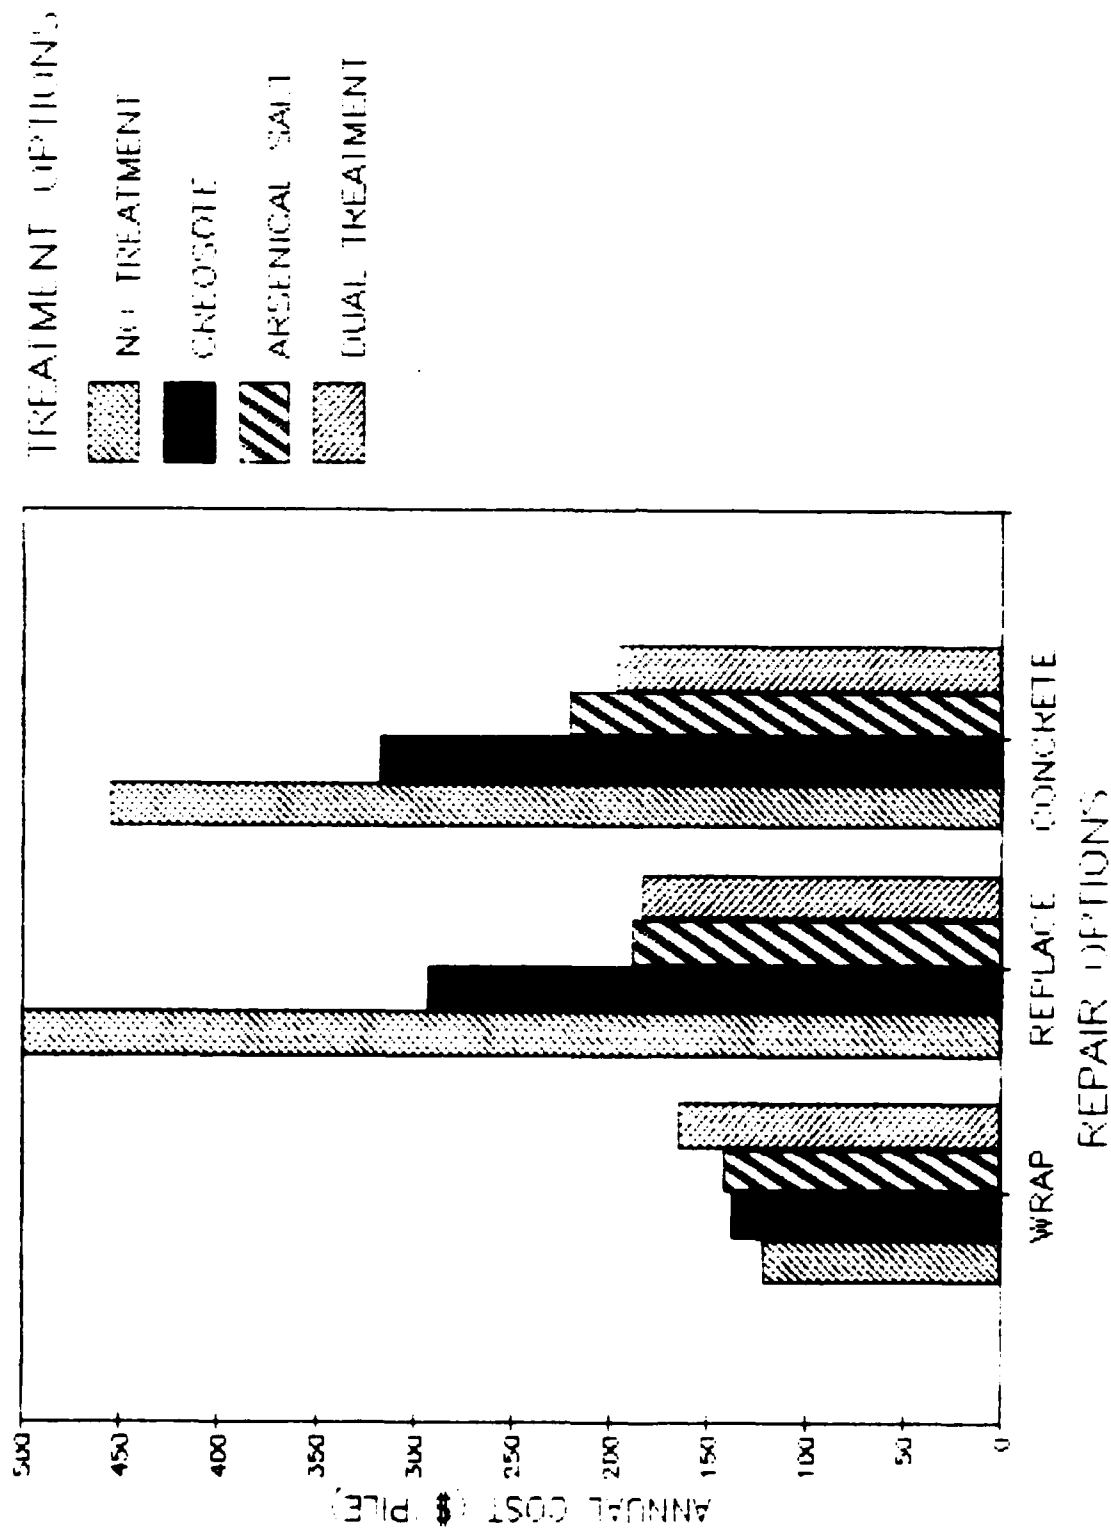
Figure 2. Calculated annual costs of marine timber bearing piling treatment and repair options in subtropical areas.

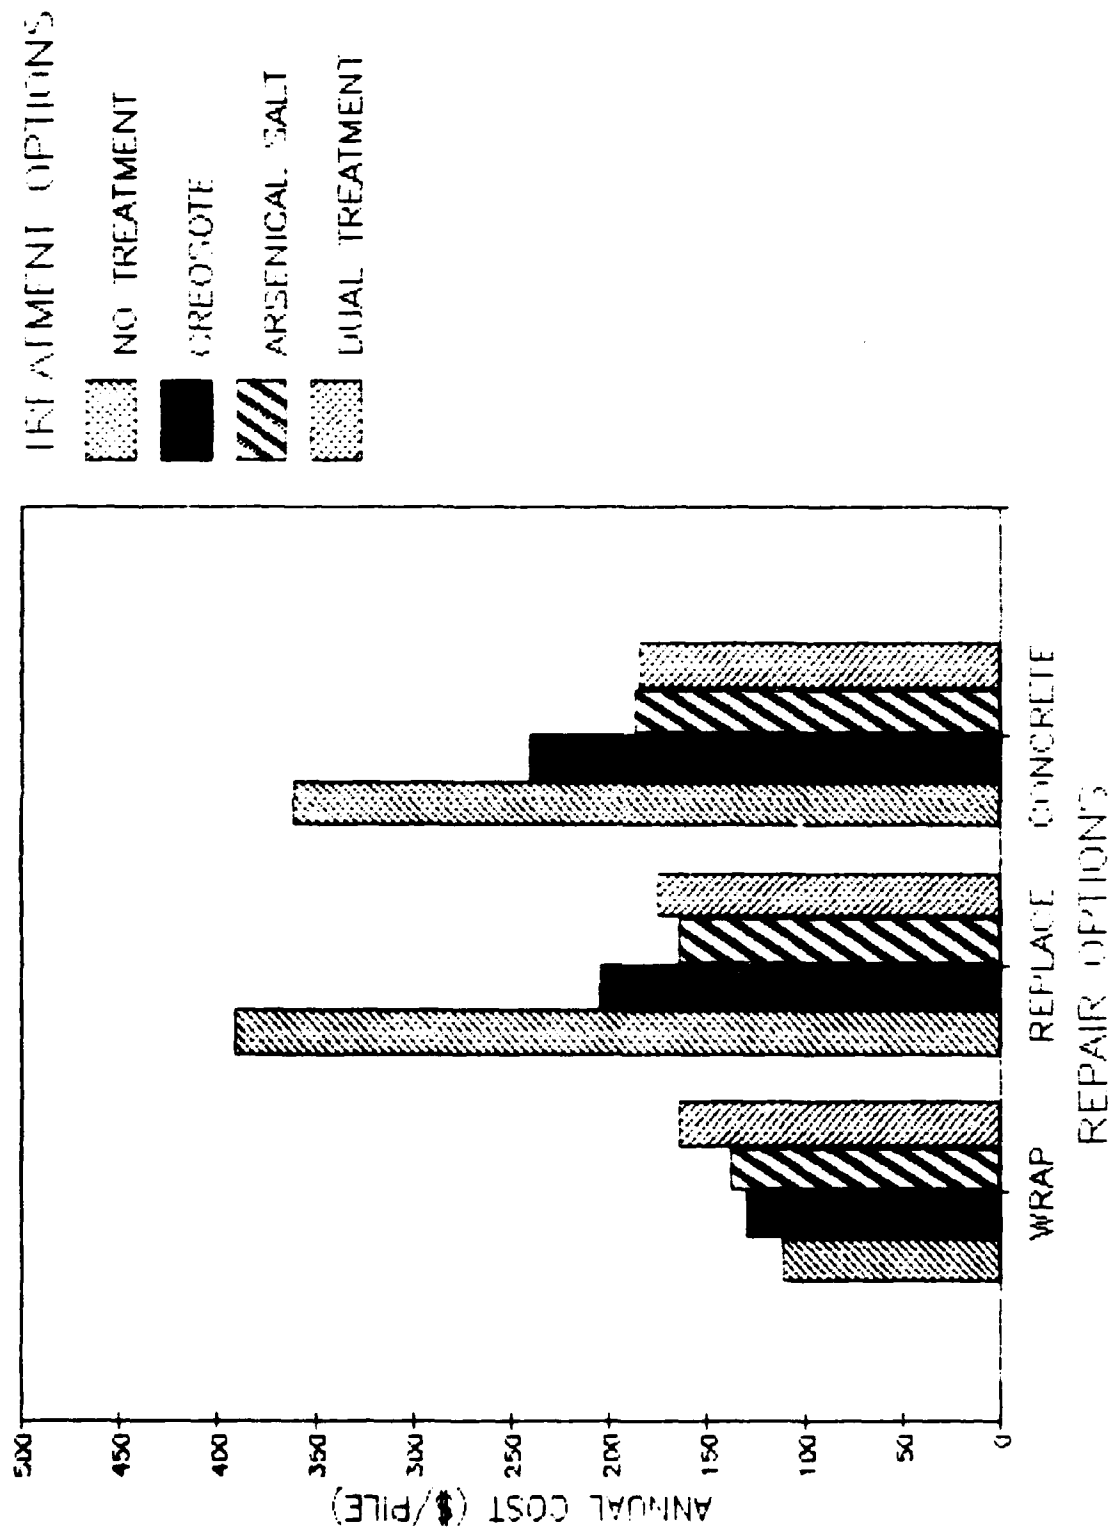
Figure 3. Calculated annual costs of marine timber bearing piling treatment and repair options in temperate areas.

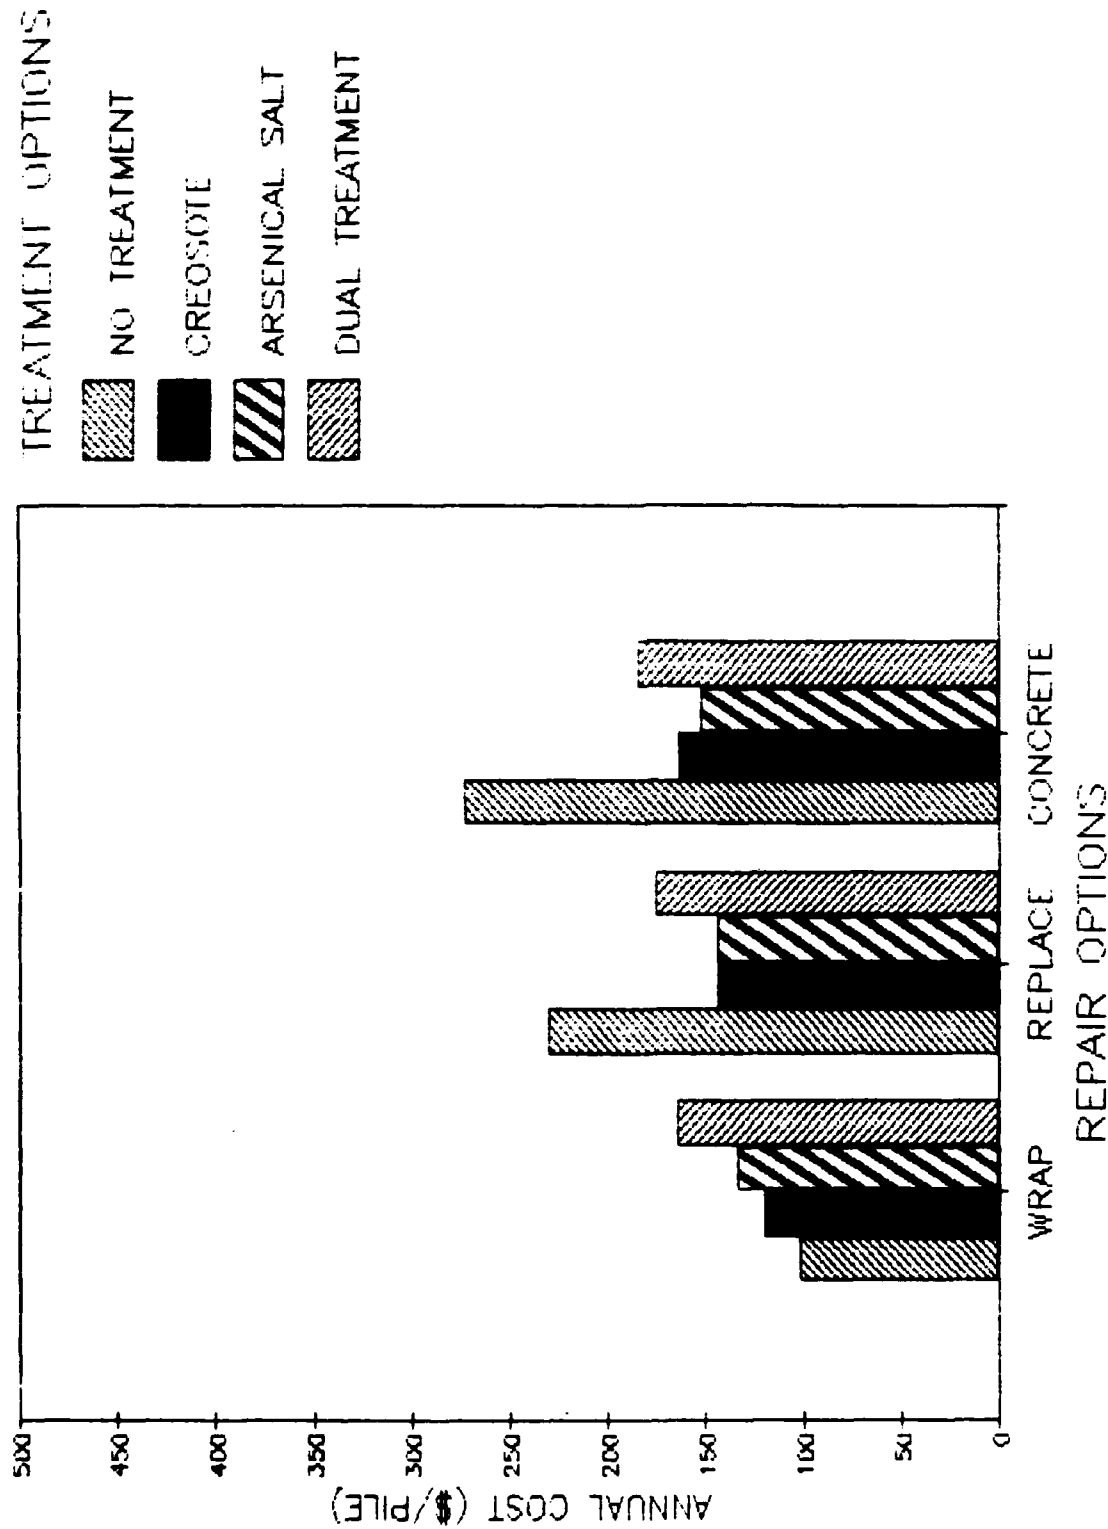
Figure 4. Calculated annual costs of marine timber bearing piling treatment and repair options in polar areas.

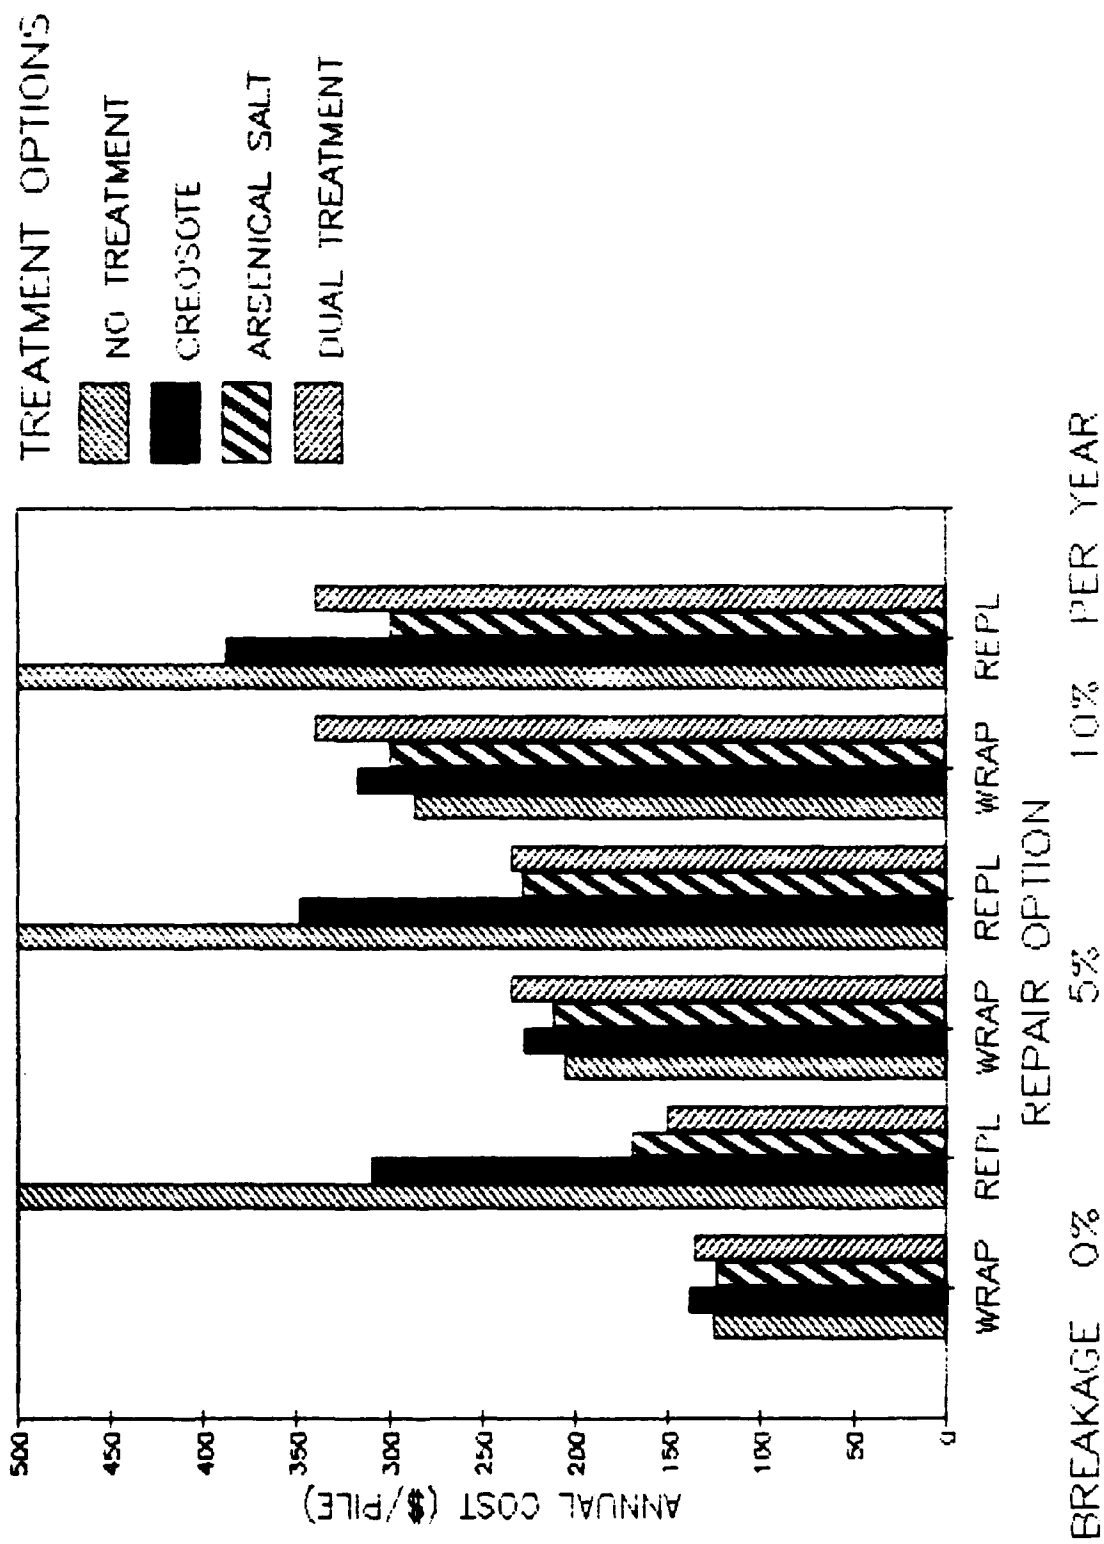
Figure 5. Calculated annual costs of marine timber fender piling treatment and repair options in tropical areas.

The annual cost of installing fender piling (Table 4; Figures 5 through 8) is dependent on geographical location, pile treatment, repair or protection method, and annual breakage rate. The installation of untreated fender piling, while included in Table 4, is not recommended because long-term testing of untreated fender piling, like untreated bearing piling, has not yet been completed. The installation of fender piles prewrapped with PVC or PE or precoated with PU (Table 5) is also not currently recommended for the same reason. These options may be available in the future, however, and cost estimates for untreated piling are presented for comparison with currently proven systems.

Figures 5, 6 and 7 indicate that the least expensive, proven system for fender piling installation and maintenance in tropical, subtropical, and temperate areas and where breakage is less than 10 percent, is the arsenical treated piling protected by PVC wrapping when required. In polar regions the costs of arsenical treated and creosoted piling protected by PVC wrapping are comparable for all breakage rates (Figure 8). Replacing fender piles is more expensive than protecting piles by PVC wrapping in all areas where the need for piling maintenance due to marine borer damage is not eliminated by pile breakage. Of course, if the breakage rate is high enough and the chemical treatment good enough to prevent borer damage before breakage occurs, than the logical option is to replace the broken piles.

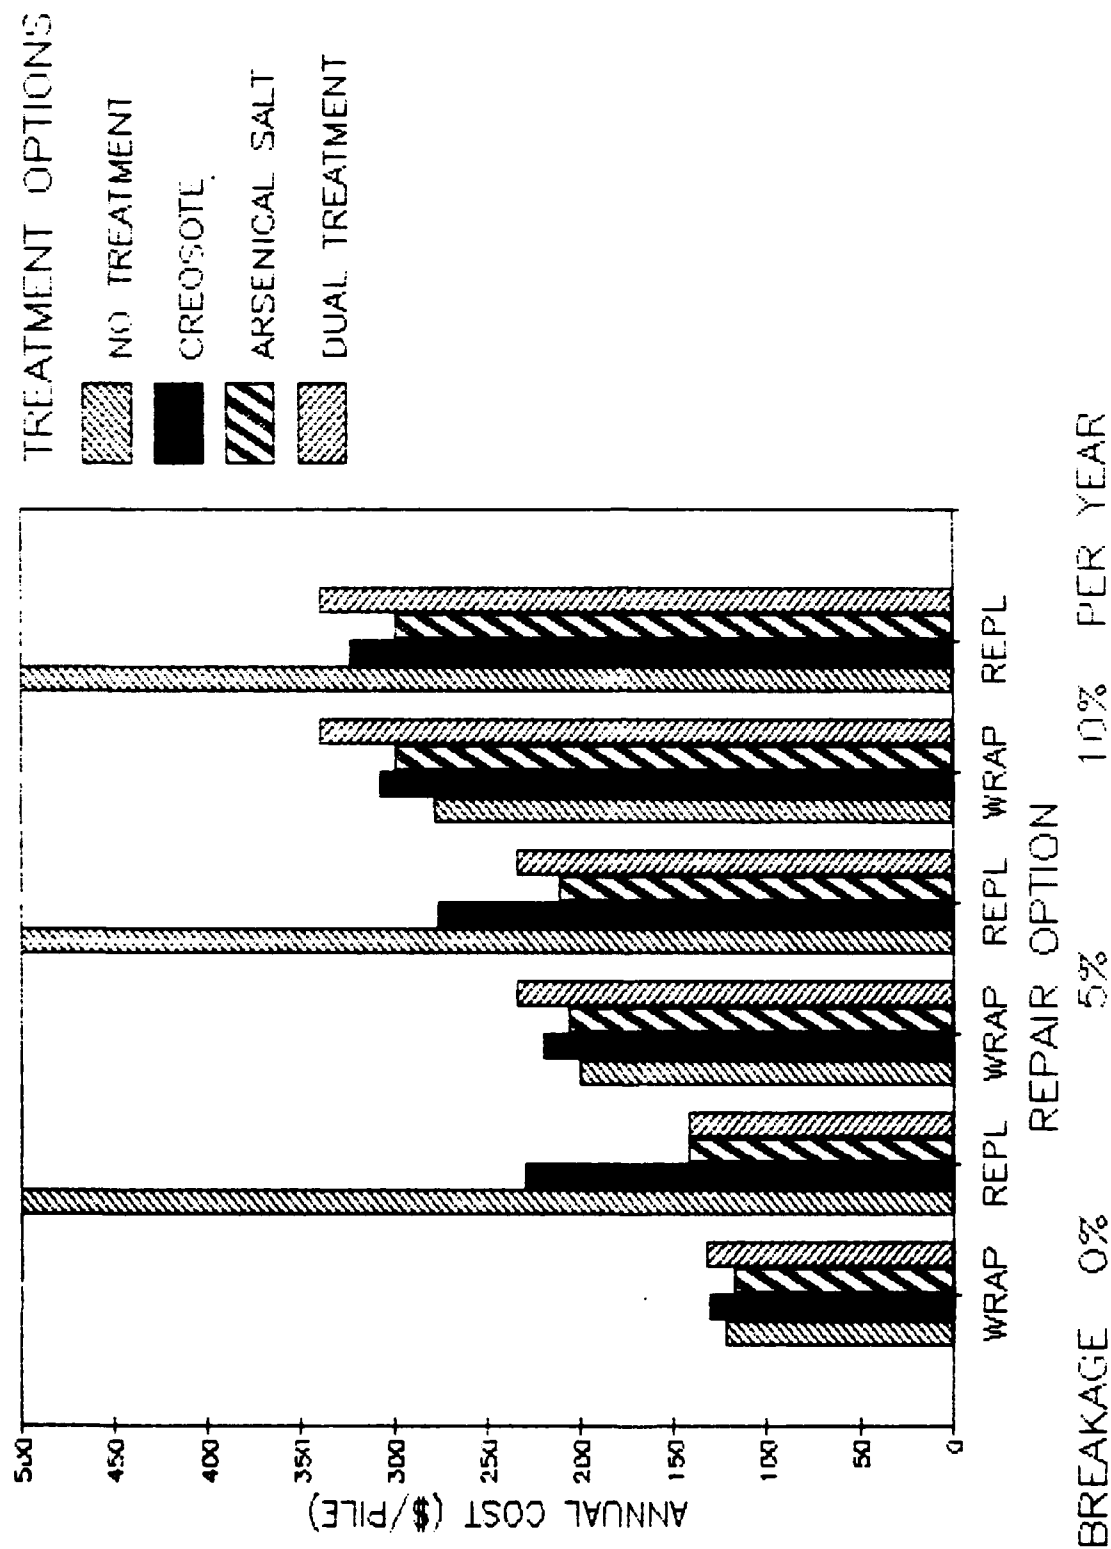
Figure 6. Calculated annual costs of marine timber fender piling treatment and repair options in subtropical areas.

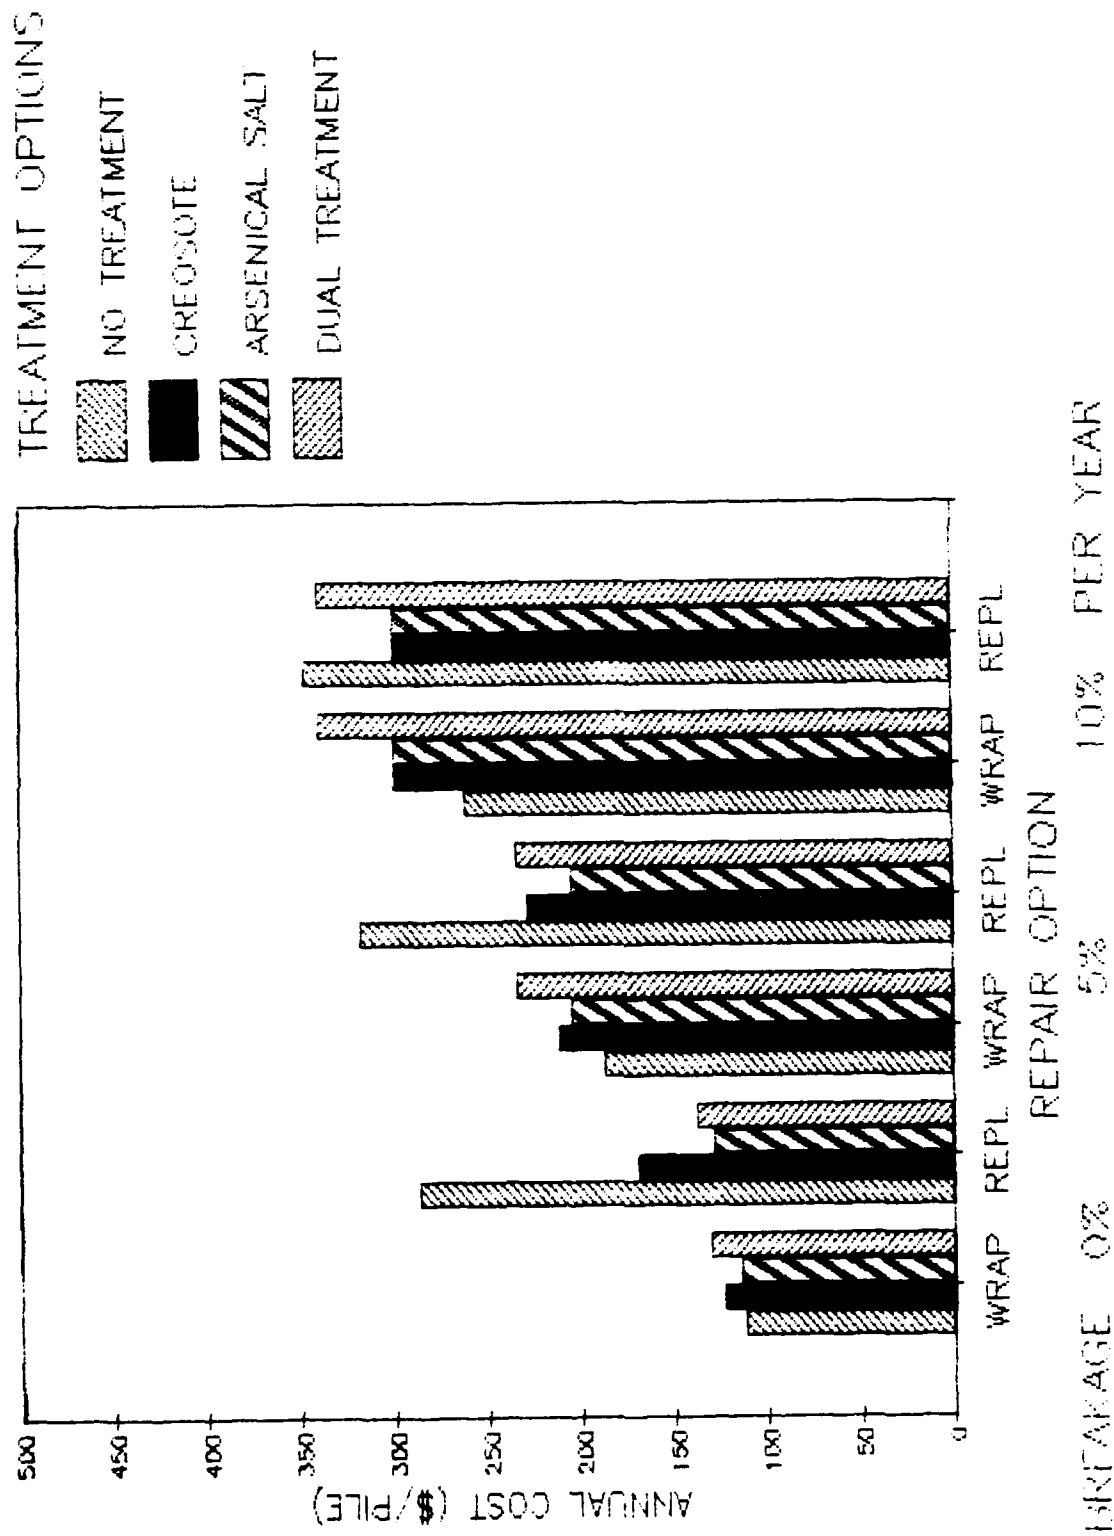
Figure 7. Calculated annual costs of marine timber fender piling treatment and repair options in temperate areas.

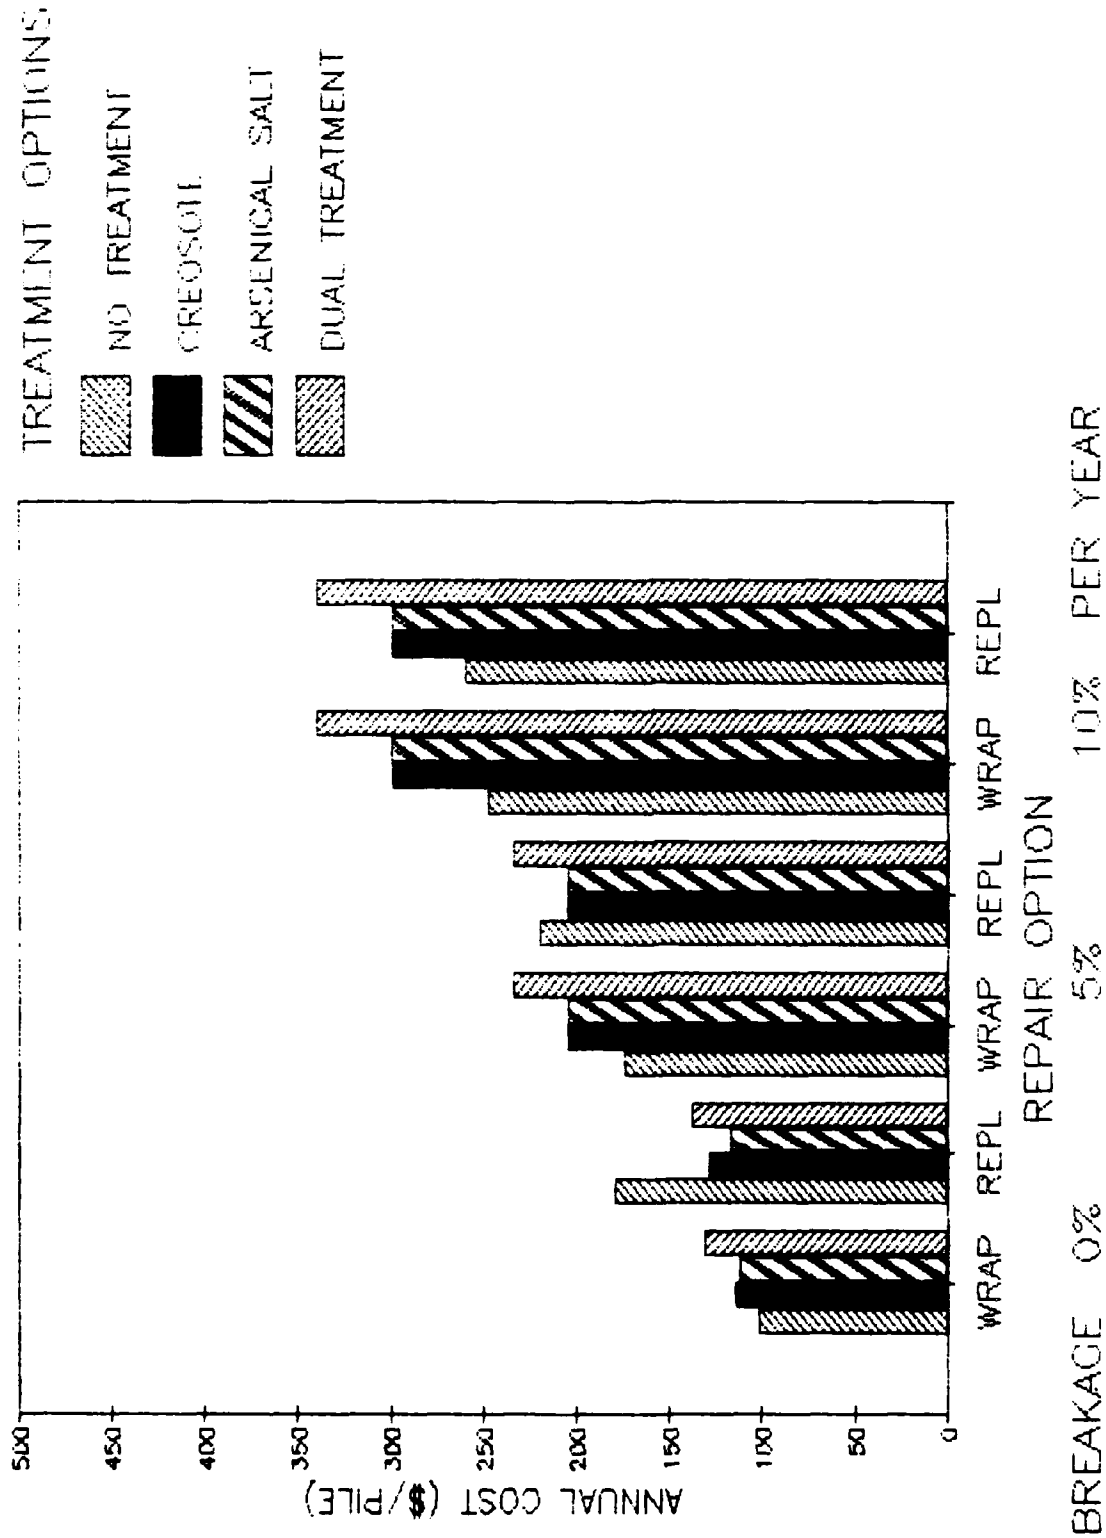
Figure 8. Calculated annual costs of marine timber fender piling treatment and repair options in polar areas.
